A Study of Farm Animals Near 765 KV Transmission Lines

Harold E. Amstutz, B.S., D.V.M.

David B. Miller, Ph.D., P.E.

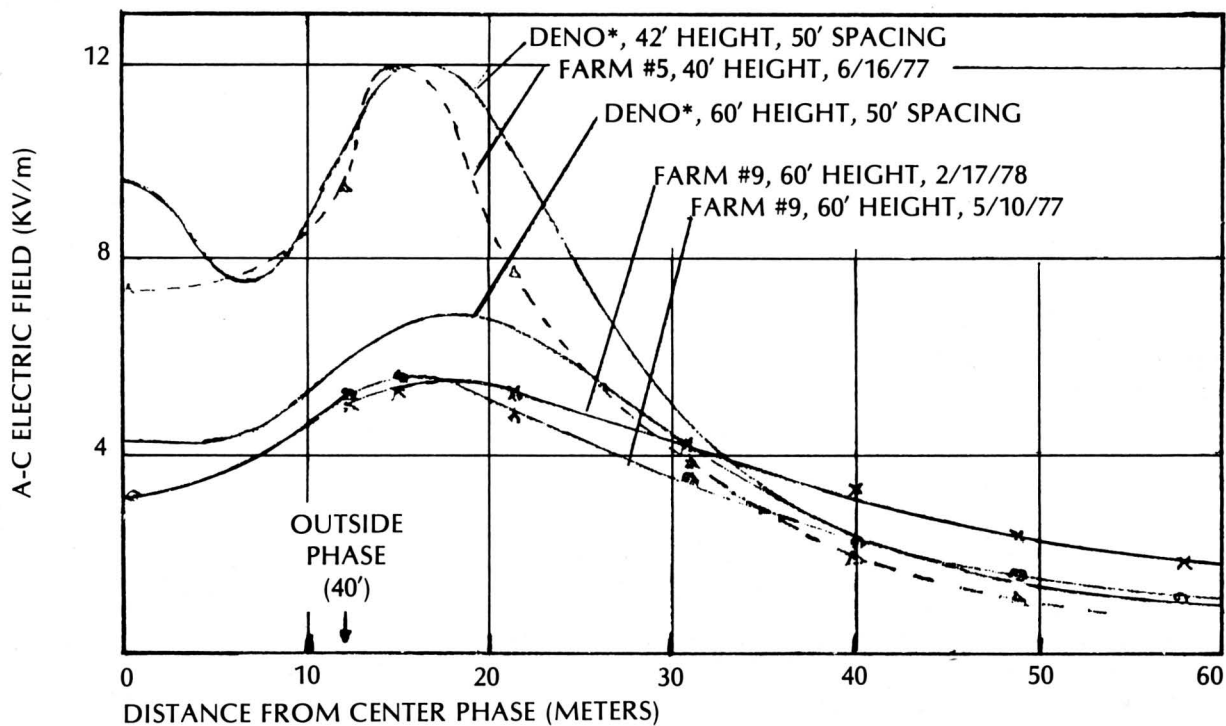
Typical Electric Field Data

Generally, one or more traverses were made, perpendicular to the line, 1 meter above the ground. Mappings parallel to the line, in some cases, were also made. At one meter, the electric field was, in all cases, perpendicular to the ground and the Field Meter was held in the proper position to record this vertical component. In all cases, the maximum E-field (at one meter height) in each farm's grazing area was recorded. Some representative plots are shown, along with calculated curves taken from the reference cited. The following conclusions can be drawn from these curves:

a. The data for a given site are in reasonable agreement with the theoretical calculations, taking into consideration differences in spacing and non-flatness of the actual topography.

b. Comparing the two sets of data taken for the same location of Farm #9, suggests that winter conditions cause the field strength to hold at higher values for further distance away from the line. This could be caused by winter ground level being higher, possibly because of the frozen ground and one-foot layer of snow, and also by the conductor height change due to temperature. This same type of Spring/Winter difference was also found on Farm #10, as can be seen from the data on the tabulation sheets.
